**Portable Coverage – Two Site TALK-IN (Voter) (As Discovered)**

#### **Draffenville Tower:**

**Dispatch Center:**

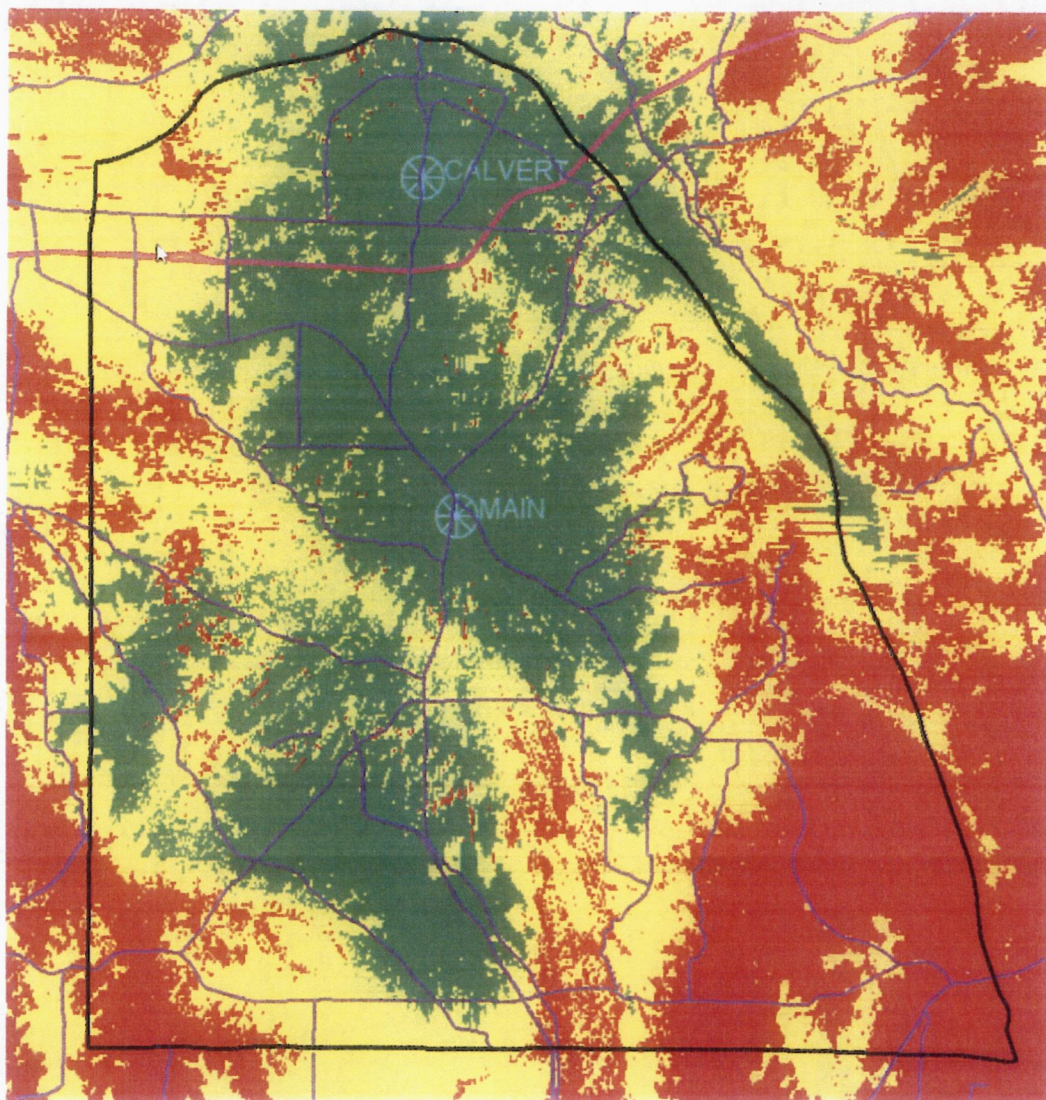
**76.3% Coverage of Marshall County Boundaries meets -95dbm (Yellow)**

**This coverage represents an inbound call to dispatch. Outbound coverage limited to Main Site footprint.**

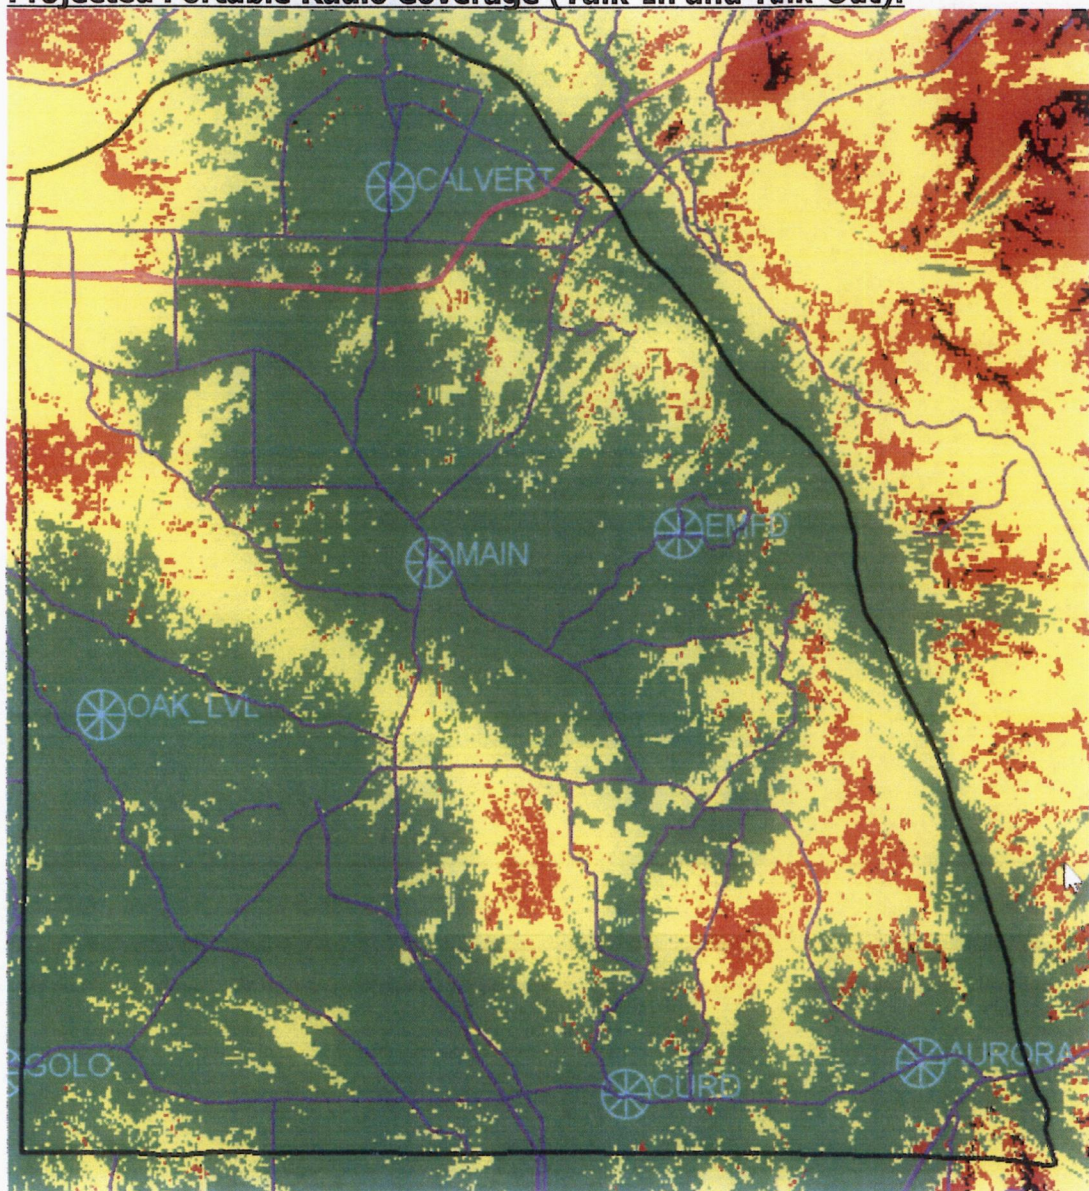
**Projected Portable Radio Coverage (Talk-In and Talk-Out):**

**96.1% Coverage of Marshall County Boundaries meets -95dbm (Yellow)**

**This coverage represents an inbound call to dispatch. Outbound coverage is engineered to match the inbound; resulting in the same mapping.**
