FACILITY EVALUATION

MARSHALL COUNTY JUDICIAL BUILDING

Executive Report

80 Judicial Drive
Benton, KY 42025

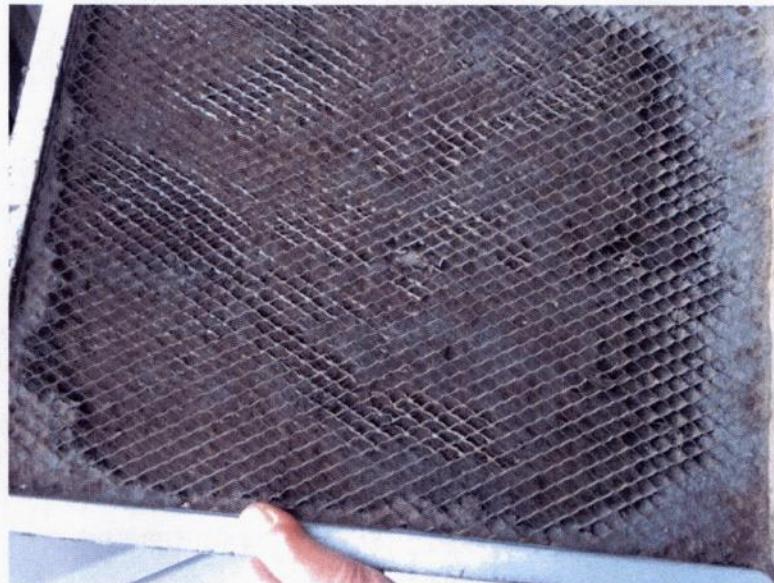
Figure 1

Based on these findings, we advised the Fiscal Court that it would be prudent to conduct a follow-up Test and Balance exercise on the rooftop ventilation-air unit tagged ERV-1. On Thursday, May 14th, 2019 Mr. Steve Brown, Test and Balance Technician with Thermal Balance, Incorporated conducted this effort (*Appendix D*). Upon arrival, he observed that the metal prefilters serving the unit were severely occluded with accumulated debris (*Figure 1*). Prior to removing the metal prefilters, the total ventilation supply-air rate was 1,551 CFM and the total exhaust-air rate was 4,566 CFM, resulting in a <3,015> CFM volumetric offset. Upon removing the metal prefilters, the total ventilation supply-air rate increased to 4,332 CFM, resulting in a <234> CFM volumetric offset. These results are summarized in *Appendix E*.

Priority #2a- Successfully address building relative pressure. Reduce both the incoming and outgoing ventilation and exhaust airflows for the unit tagged ERV-1 to the lowest values respectively which will meet the minimum ventilation requirements outlined in ASHRAE Standard 62.1-2010 while assuring a net positive volumetric balance to mitigate uncontrolled infiltration. After further consultation and discussion it may be prudent at this juncture to replace this unit given its age (i.e. ~18 years) and configuration (i.e. no refrigeration-based cooling/dehumidification). If it is decided that the existing unit will remain for an indeterminate period of time, it is recommended that steps are taken to tune the unit up to assure that the unit be configured to deliver more ventilation supply than it exhausts, that the energy recovery ventilator (ERV) wheel is clean and that the metal prefilters are replaced.

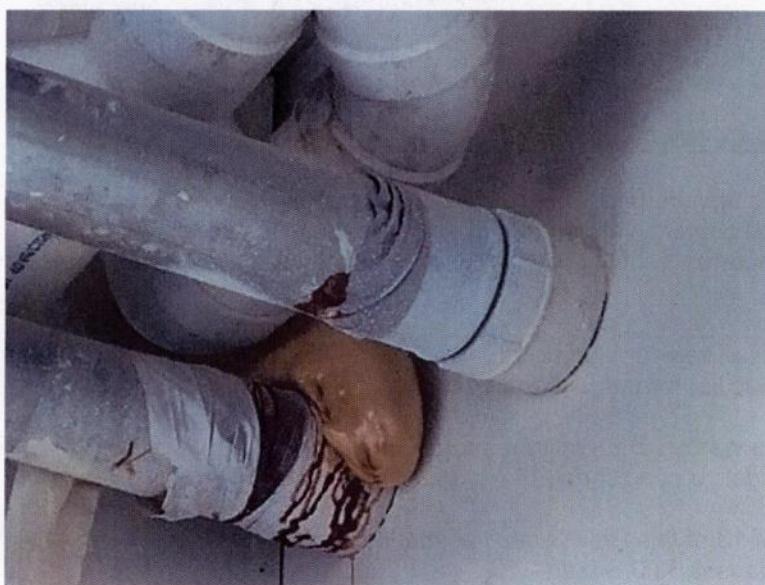
Figure 2

While onsite, we observed several locations within the basement area which either previously or are currently experiencing periodic rainwater intrusion (see *Figure 2*). Of particular note is what appears to be a significant leak through the two (2) telecommunications conduit pathways entering a basement space referred to as '*Evidence Storage*'. The significant rainfall event of March 13th and 14th confirmed this, when rainwater was observed by Mr. Gary Teckenbrock entering the space from the interior of one (1) of the pathways in question.

Based on these findings, we advised the Fiscal Court that it would be prudent to engage AT+T (telephone) and Spectrum Communications (cable television) in an effort to successfully remediate this concern.

Priority #1a- Identify and seal all active above/below grade sources of rainwater intrusion. It is recommended that the cable TV conduit end is appropriately sealed against rainwater intrusion. Should intrusion continue after this end is sealed, it would be judicious to uncover the parallel conduits in progressively closer intervals to the building in an attempt to isolate the breach(es) in the pathways. Should the breach occur under the portion of the building (i.e. Clerk's suite) that is not over the basement it might entail installing a new pathway as an example of the most evasive remediation scope.

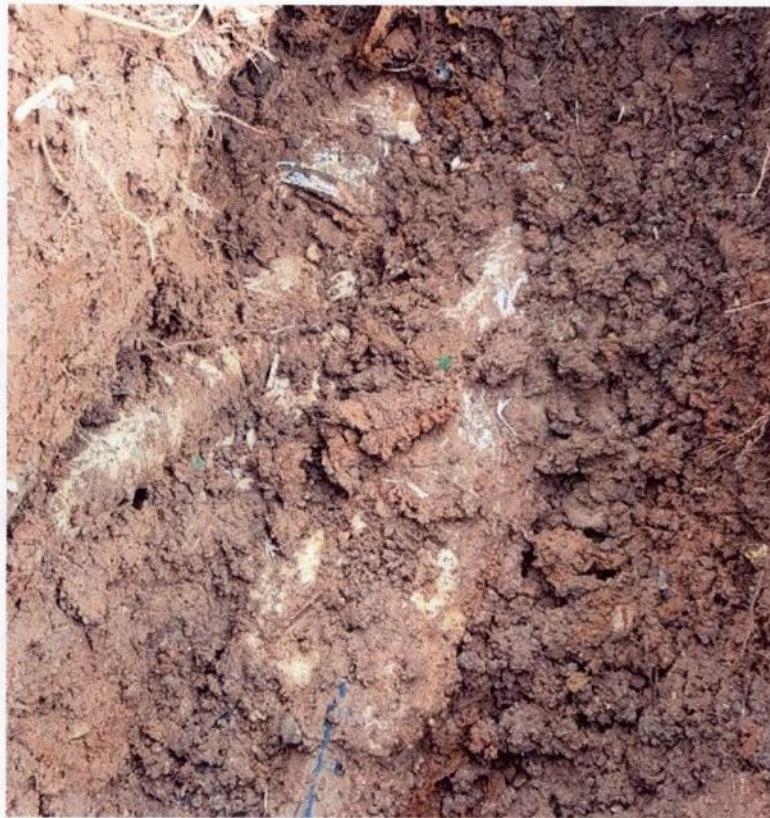
Figure 3

On Wednesday, March 13th, Mr. Gary Teckenbrock and I met with AT+T's installation subcontractor (Star Construction). After a brief consultation, they manually excavated at the pole in the Southwest corner of the property to expose both the telephone and cable TV conduits (two (2) parallel 4" Ø conduits- see *Figure 3*). Following, Mr. Mike Huffmaster with AT+T came by to inspect the conduit end serving as the pathway for the telephone service and judged it to be sufficiently sealed against water intrusion. At the time of this writing, technicians from Spectrum Communications are scheduled to conduct a site evaluation of the exposed communications conduit serving the cable TV connection at 1:00 p.m. CDT on Friday, March 22nd.

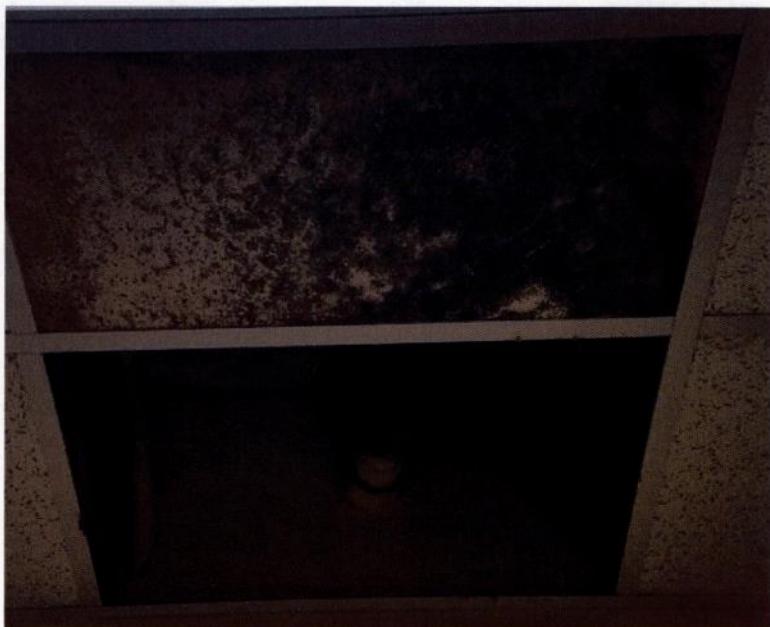
Figure 4

While onsite, we observed several locations within the facility which appear to have experienced periodic hydronic and/or condensate leaks. The most pronounced example of this was observed in the workroom adjacent to the Circuit Judges' reception area (*Figure 4*).

Priority #1b- Identify and address all interior hydronic/condensate leaks.

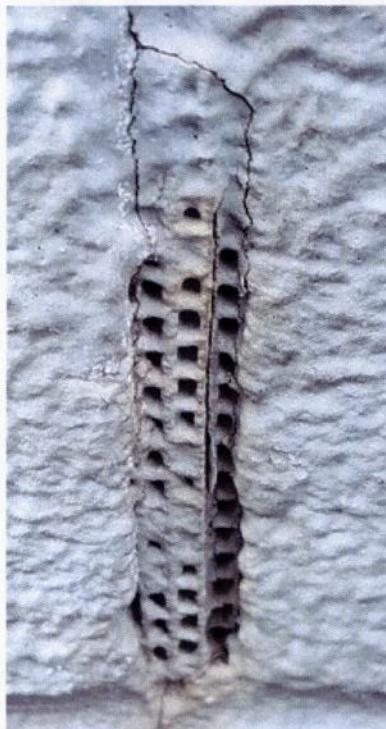
1. There appear to be brick vents installed periodically throughout the brick veneer, but most appear to have been sealed over- presumably by the brick sealing process executed in 2011. *Figure 5* identifies an open brick vent found above-grade on the East side of the facility and *Figure 6* identifies the typical application of sealant media over a location containing a brick vent.

Priority #3- Following (1a/b) and (2a/b), monitor/test for reoccurring indoor air quality issues. If the issue persists following successful resolution of Items #1a/b and #2a/b above, evaluate wall assembly remediation.

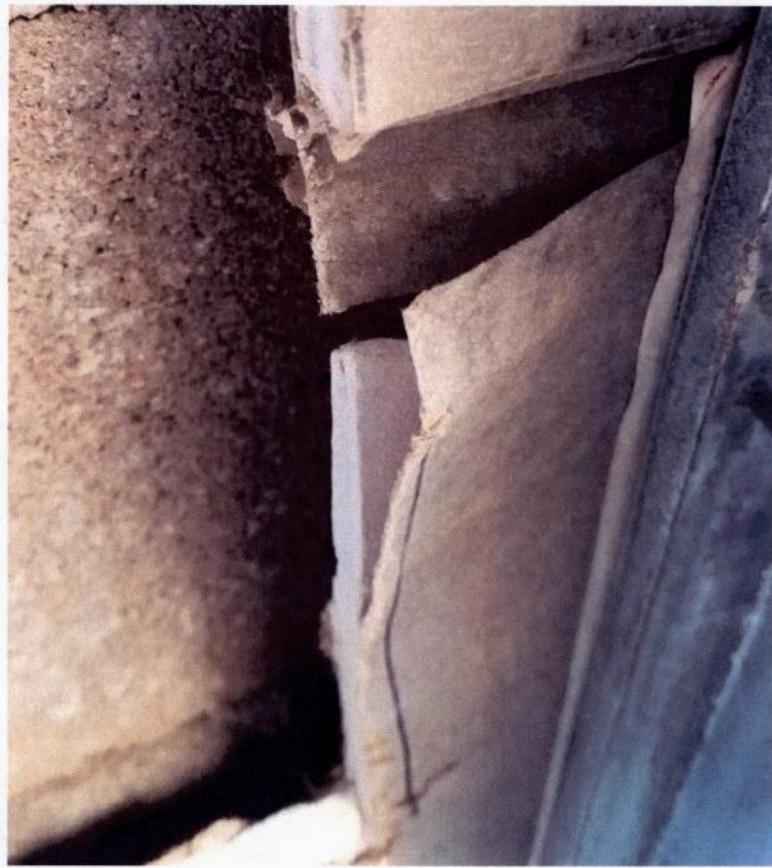
Figure 7

2. There does not appear to be a vapor barrier installed within the envelope cross-section in the very limited areas open and available for review from the interior. *Figure 7* is a photo from the interior of the District Judges' chambers and is typical for the locations where the interior gypsum wall board has been removed for evaluation.

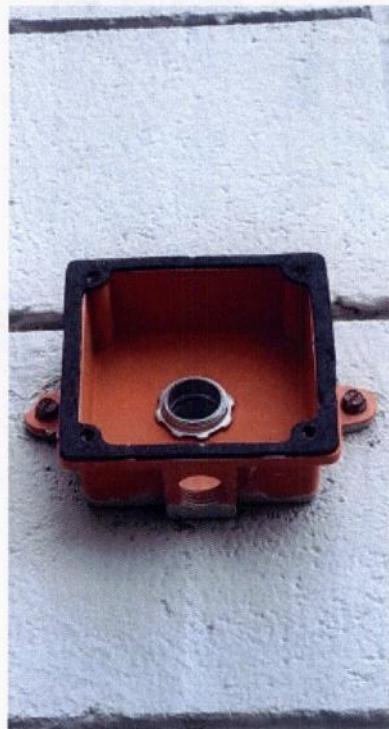
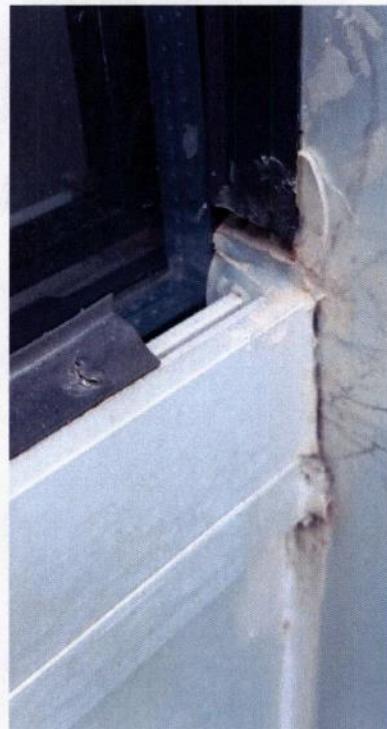
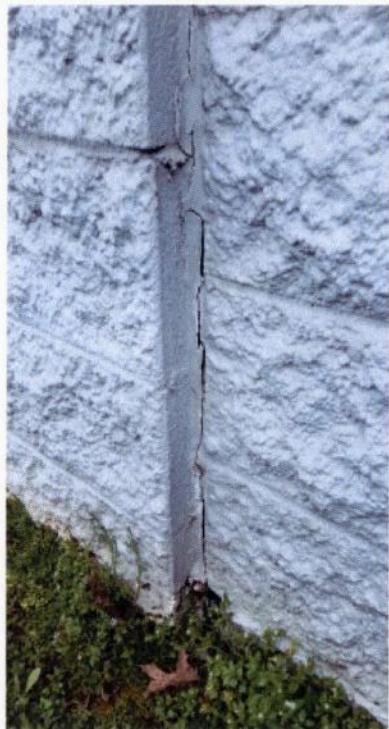
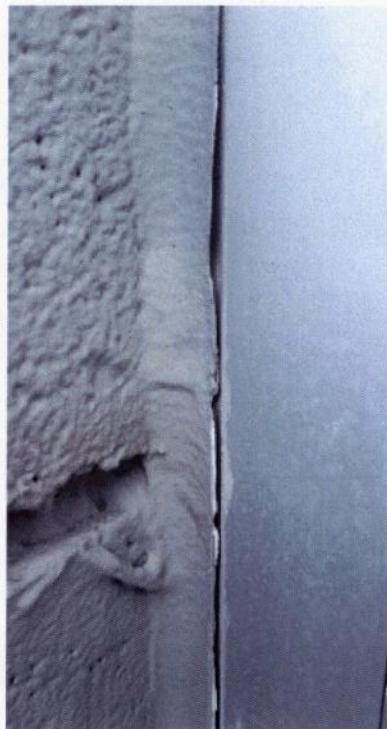
3. There appear to be numerous instances along the scope of the exterior envelope where voids, connections, penetrations, etc. are open and could present opportunity for rainwater impingement and/or significant air migration. *Figures 8 thru 11* respectively represent typical observations.

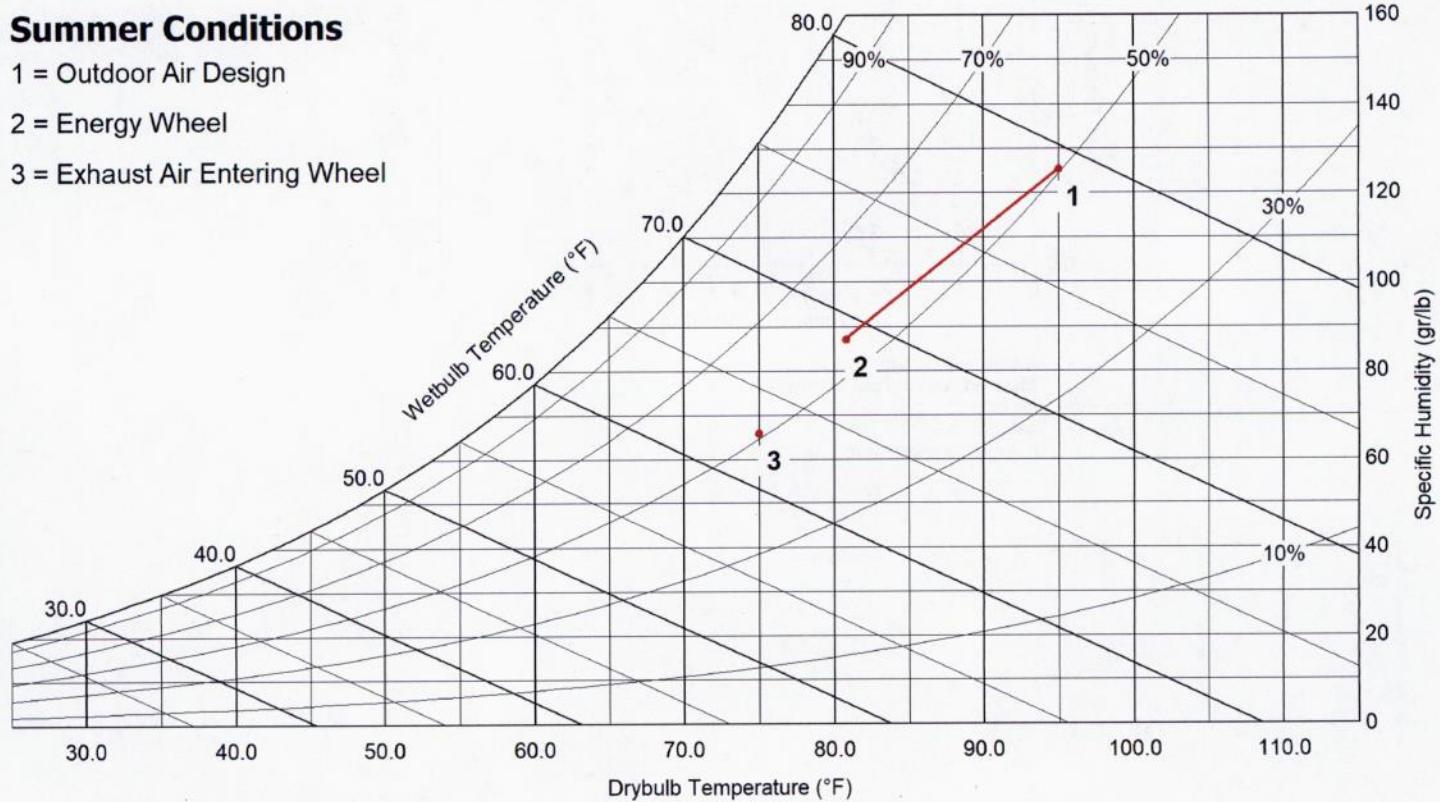
Energy Recovery Summer Performance

Outdoor Air		Supply Air	
Dry Bulb (F)	95.0	Dry Bulb (F)	80.8
Wet Bulb (F)	78.7	Wet Bulb (F)	68.6
Specific Humidity (gr/lb)	125	Specific Humidity (gr/lb)	87
Enthalpy (BTU/lb)	42.6	Enthalpy (BTU/lb)	33.0

As noted on page 6 of 13 of the '*ERV Submittal*' that the predicted 'Supply Air' enthalpy at the specified design cooling conditions is 33.0 BTU/lb.

What this seeks to underscore is that delivering ventilation-air with an enthalpy of 33.0 BTU/lb. induces a non-trivial amount of space load and resultant moisture burden that must be effectively managed during hot and humid outside conditions. To demonstrate this point, we can hold enthalpy constant at 33.0 BTU/lb. and temperature constant at 72° F db and 74° F db respectively and can calculate the resultant relative humidity:
